CENTRAL EUROPEAN FLOODING AUGUST 2002

An EQECAT Technical Report

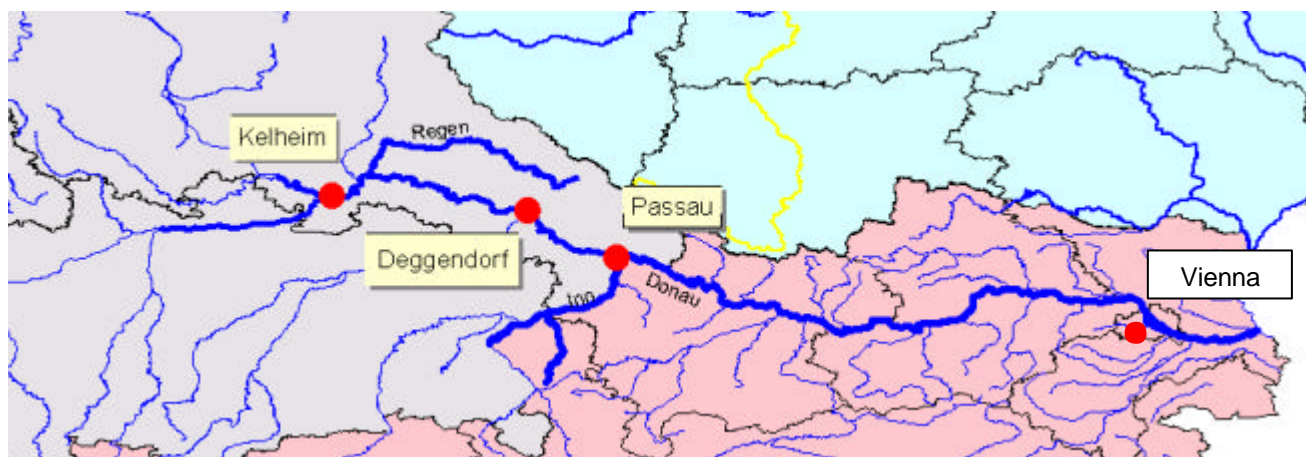
Fig. 12: Water level vs. time on the upper Donau, at Passau, Deggendorf and Kelnheim. The locations of the stations are shown below:

Serious flooding also resulted on the Donau in Germany and Austria, along with the Inn and the Regen. Further downstream, water levels were lower, and only minor flooding resulted in Vienna and Hungary. In the upper reaches of the Donau in Germany, the towns of Regensburg, at the confluence of the Regen with the Donau, and Passau, at the confluence of the Inn and Donau, were flooded. Fig. 12 shows gauge traces from Kelnheim (upstream of Regensburg), Deggendorf and Passau in Germany.

As on the Elbe, the two water level resulting from the two events can clearly be distinguished; on this part of the Donau, however, water levels were able to return almost to normal levels before the onset of the second event. The flood peak from the Donau moved downstream from Kelnheim, through Deggendorf to Passau. The double peak at Passau results from the influx of water from the Inn river prior to that from the Donau. The water level seen at Passau during the event broke all historical records.

Further downstream, flooding of the Donau was relatively minor compared to that seen on the middle reaches of the Elbe. Only minor flooding resulted in Vienna and further downstream in Hungary. The trace of the flood peak for Budapest is also shown in Fig. 12.

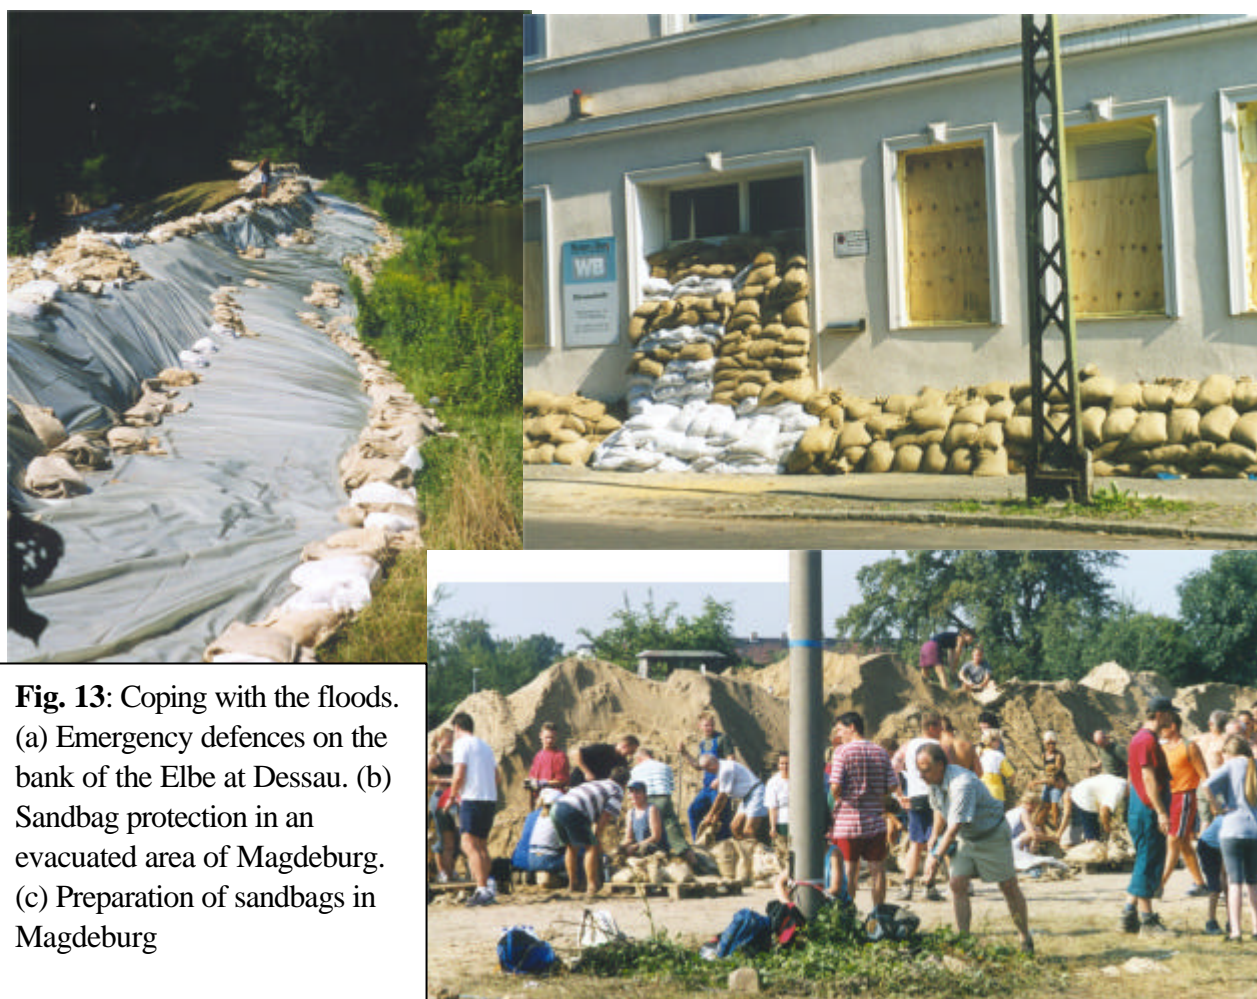
Fig. 13: Coping with the floods.
(a) Emergency defences on the bank of the Elbe at Dessau. (b) Sandbag protection in an evacuated area of Magdeburg. (c) Preparation of sandbags in Magdeburg

Prior to flooding, extensive emergency operations were undertaken in all the affected countries to improve existing flood defences, protect buildings and evacuate areas at risk. Water levels in the Donau and Elbe exceeded all expectations as to the level of flooding possible on the two rivers, and existing defences were simply not high enough to withstand water levels in many places. In Germany, both the police and the military were heavily involved with the effort to build emergency defences. The general public were also involved in constructing both defences along riverbanks, as well as in protecting their own home from flood waters. In Germany, large dumps of sand and bags were provided for public use in areas at risk from immediate flooding, along with emergency medical care facilities and communication centres.

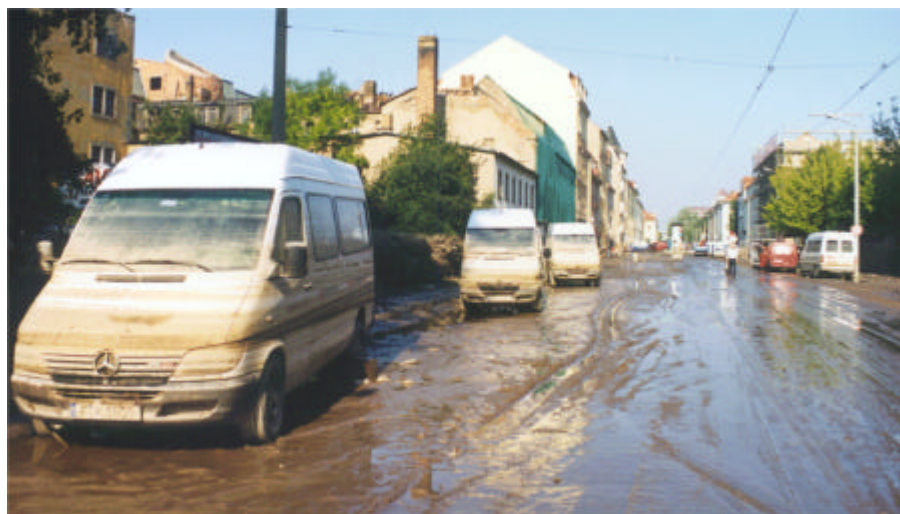
Fig. 14: Street in the centre of Dresden after the floodwaters receded

An even larger effort is required once flooding has passed, although without the time pressure. Disposal of sand bags and damaged property creates a problem in addition to the clean-up of property and streets required. In many areas, the deposition of tens of centimetres of mud, sometimes polluted, has made streets impassable. This mud must be cleared away, and drains unblocked, before the water remaining in many basements can be pumped away and damage can be repaired. Considerable loss due to business interruption is inevitable, especially in badly hit areas where the services required for a quick clean-up of buildings are over-stretched.

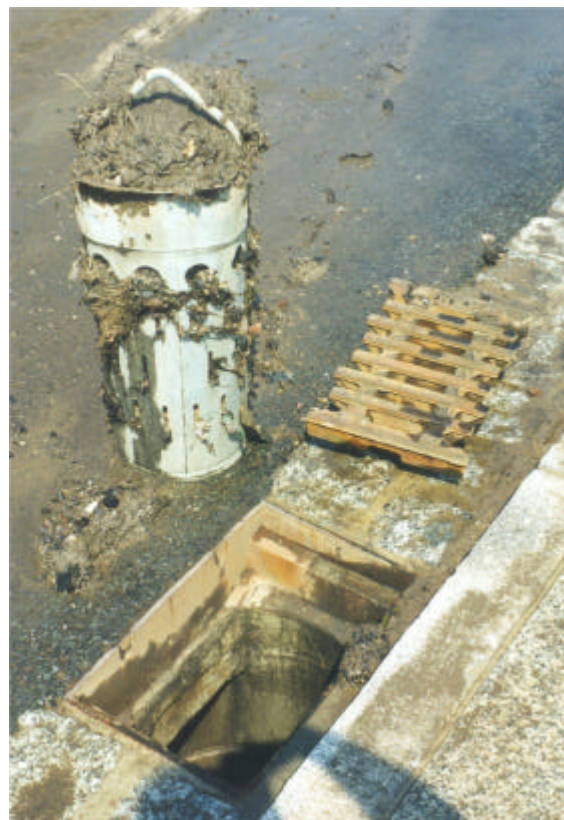
Fig. 15: Clearance of sediment from drains in Dresden

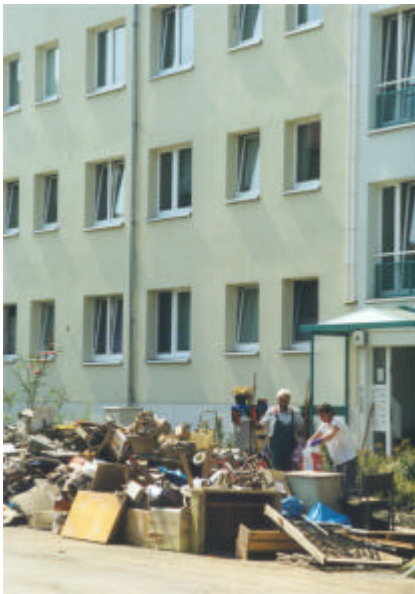
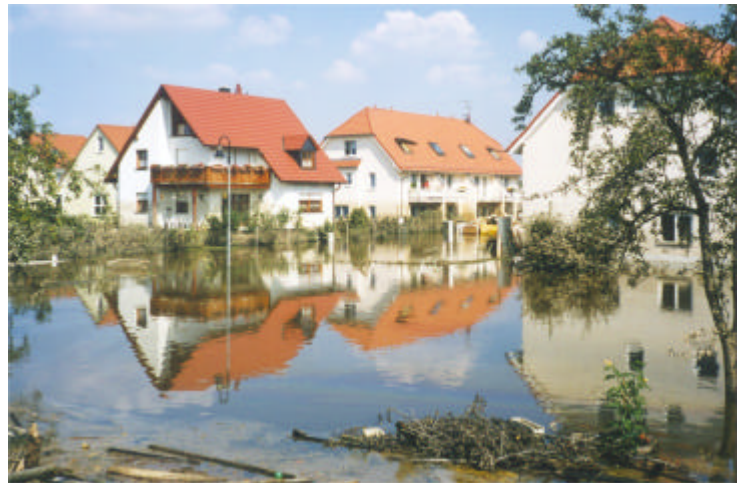
Fig. 16: Damage to housing in Dresden and Meissen. Ground floor flats were the most severely affected, with close to 100% loss to contents.

Extensive losses have occurred related to residential districts in floodplain areas. In many areas, more modern properties are especially badly affected since these have a higher tendency to be located on the flood plain. Losses to contents are particularly large, especially in single storey properties such as bungalows or ground floor apartments. Structural failure has been more common in upstream areas (Austria, Czech Republic), and close to the river channel, where water velocities have been higher. In parts of Prague, building collapse commonly resulted in buildings with sandy foundations that could be undermined by the flood waters. Further downstream (Germany), building damage is primarily due to the depth of water to which a property has been subjected. Failure of the main part of the structure is rare, but in some cases, low level windows have been broken. Damage to electrics and other utilities located in basements is widespread, as is minor damage caused by debris (e.g. trees and cars) carried by flowing water. Some collapses of weak retaining walls (e.g. garden walls) have also occurred where a wall has been sufficiently impermeable to allow water to build up on one side only.

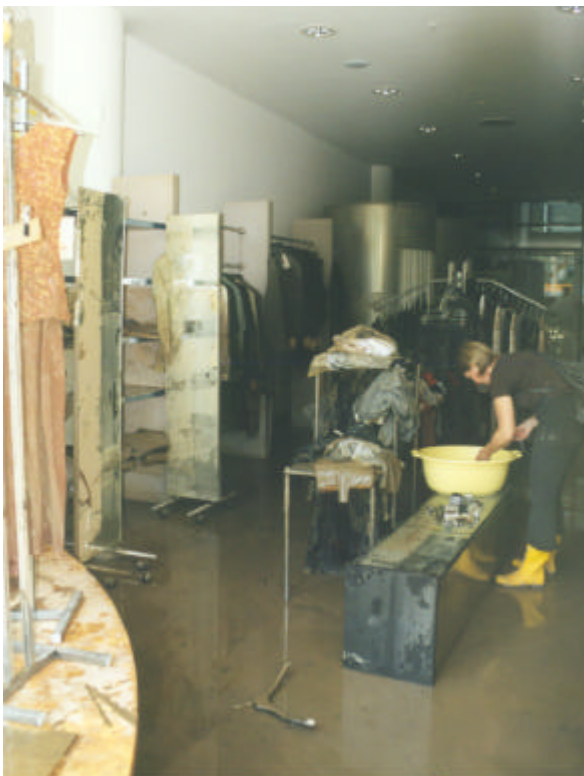
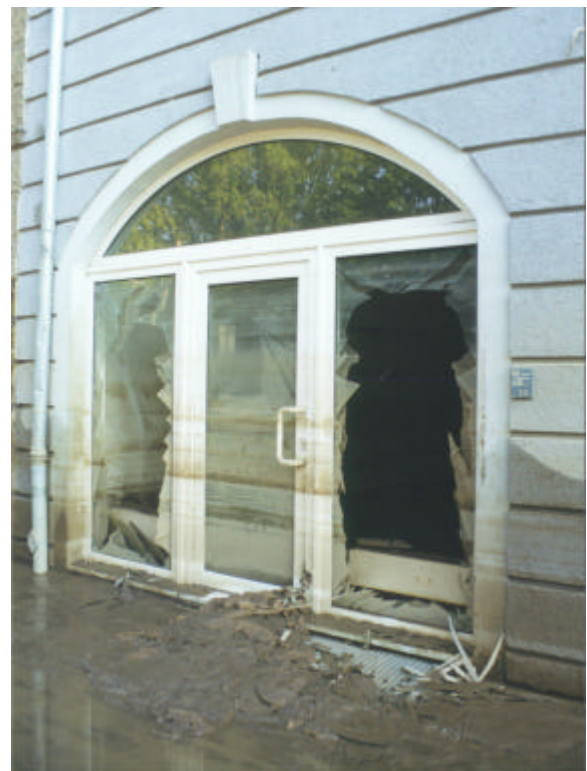
Fig. 17: Damage to commercial properties in Dresden. Large panes of glass at street level were particularly prone to damage.

In city centre areas, damage was concentrated in ground floor, single-storey commercial properties. Damage to glass-fronted small commercial properties was common. Warehouses lacking a second storey were also badly affected.

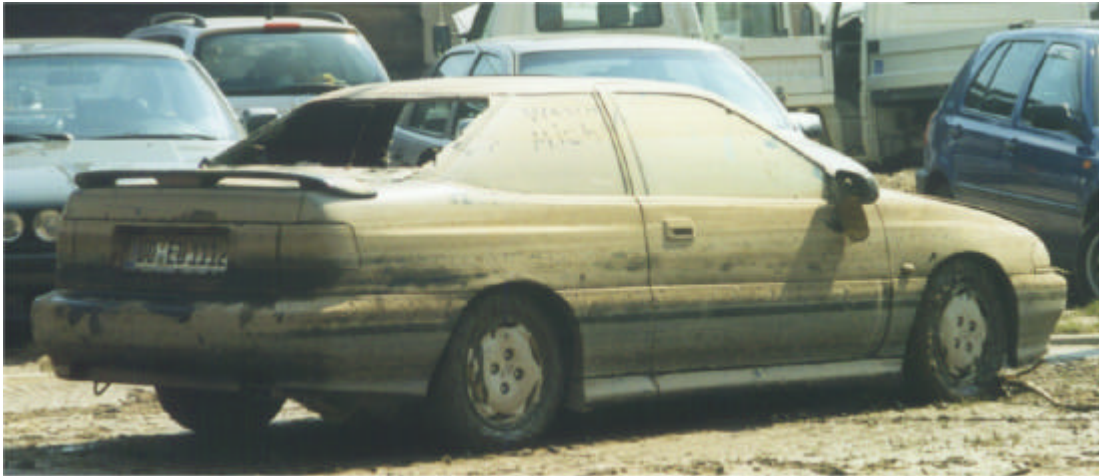
Fig. 18: Damaged vehicle in Dresden.

Motor vehicles, both privately owned and belonging to hire companies and in sales showrooms suffered a great deal of damage. In areas where there is evidence of flowing water, cars were transported tens of metres, resulting in further damage to nearby vehicles and property.

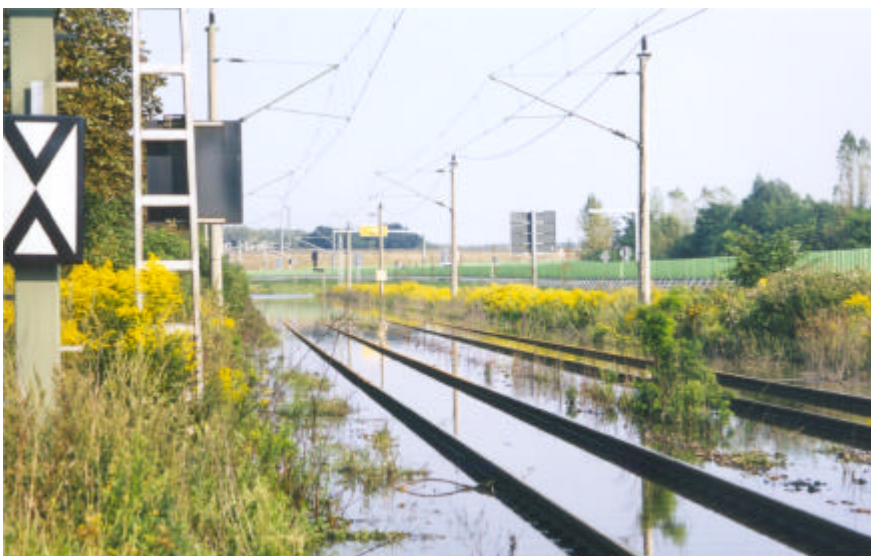
Fig. 19: Flooded railway lines in Wittenberg

Lifelines have been severely affected in many regions, with many areas suffering loss of electricity and water supplies. The transport network has also suffered due to structural damage to bridges as well as direct flooding of roads and railways. The German railways have reported losses of several hundred million euros, and many routes across the Elbe river were blocked. In Prague, all bridges across the river bar one were closed by the flooding, and the metro was severely affected.
